NATIONAL DAM SAFETY PROGRAM. COCKRAM MILL DAM (INVENTORY NUMBER--ETC(U)

NAME OF DAM: COCKRAM DAM
LOCATION: PATRICK COUNTY
INVENTORY NUMBER: VA 14105

PHASE I INSPECTION REPORT
NATIONAL DAM SAFETY PROGRAM

DECEMBER 1980

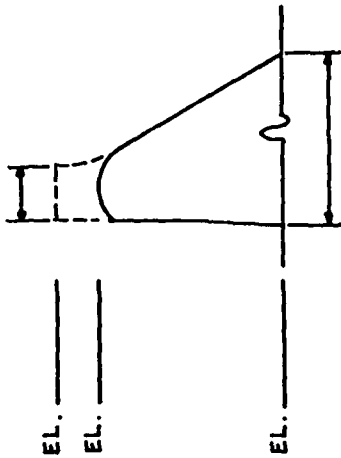
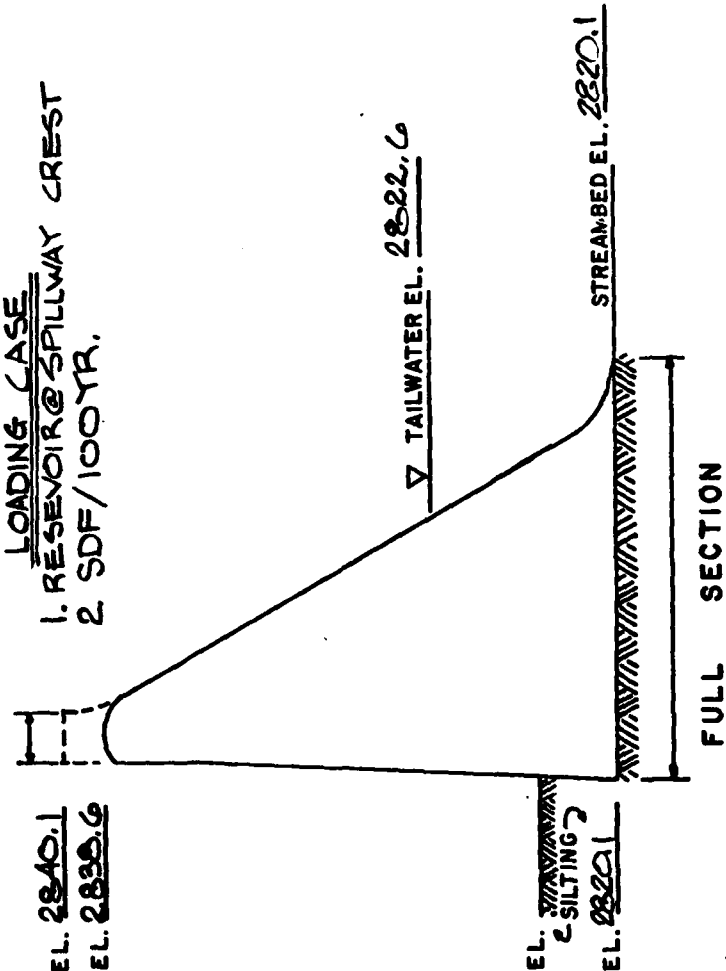
TABLE 6.1

6.1 Stability Analysis: A preliminary stability analysis was performed based on field measurements taken below the wooden walkway at the gated outlet through the dam. A one-foot section of the dam was analyzed. The results of this analysis indicate that the dam is stable under normal conditions with reservoir level at the crest of the spillway. When the 100 year flood load is applied, however, the dam is on the verge of overturning. Results of the stability analysis are summarized in Table 6.1.

6.3 Evaluation: Since the preliminary stability analysis indicates that the dam is on the verge of overturning when the 100 year storm is applied, the dam is considered to be unsafe during flood conditions.

A preliminary stability analysis of the spillway section based on field measurements at the gated outlet was performed. See Table 6.1. This analysis indicates that during flood conditions of the 100 year storm the dam is on the verge of failure. For this reason, the dam has been assessed as "unsafe non-emergency".

The first priority for further study should be to perform a stability analysis for the dam as an entire unit. The analysis for this report was based on a one foot wide section and neglects any increase in dam base width due to the slight observed arch along the crest of the dam.

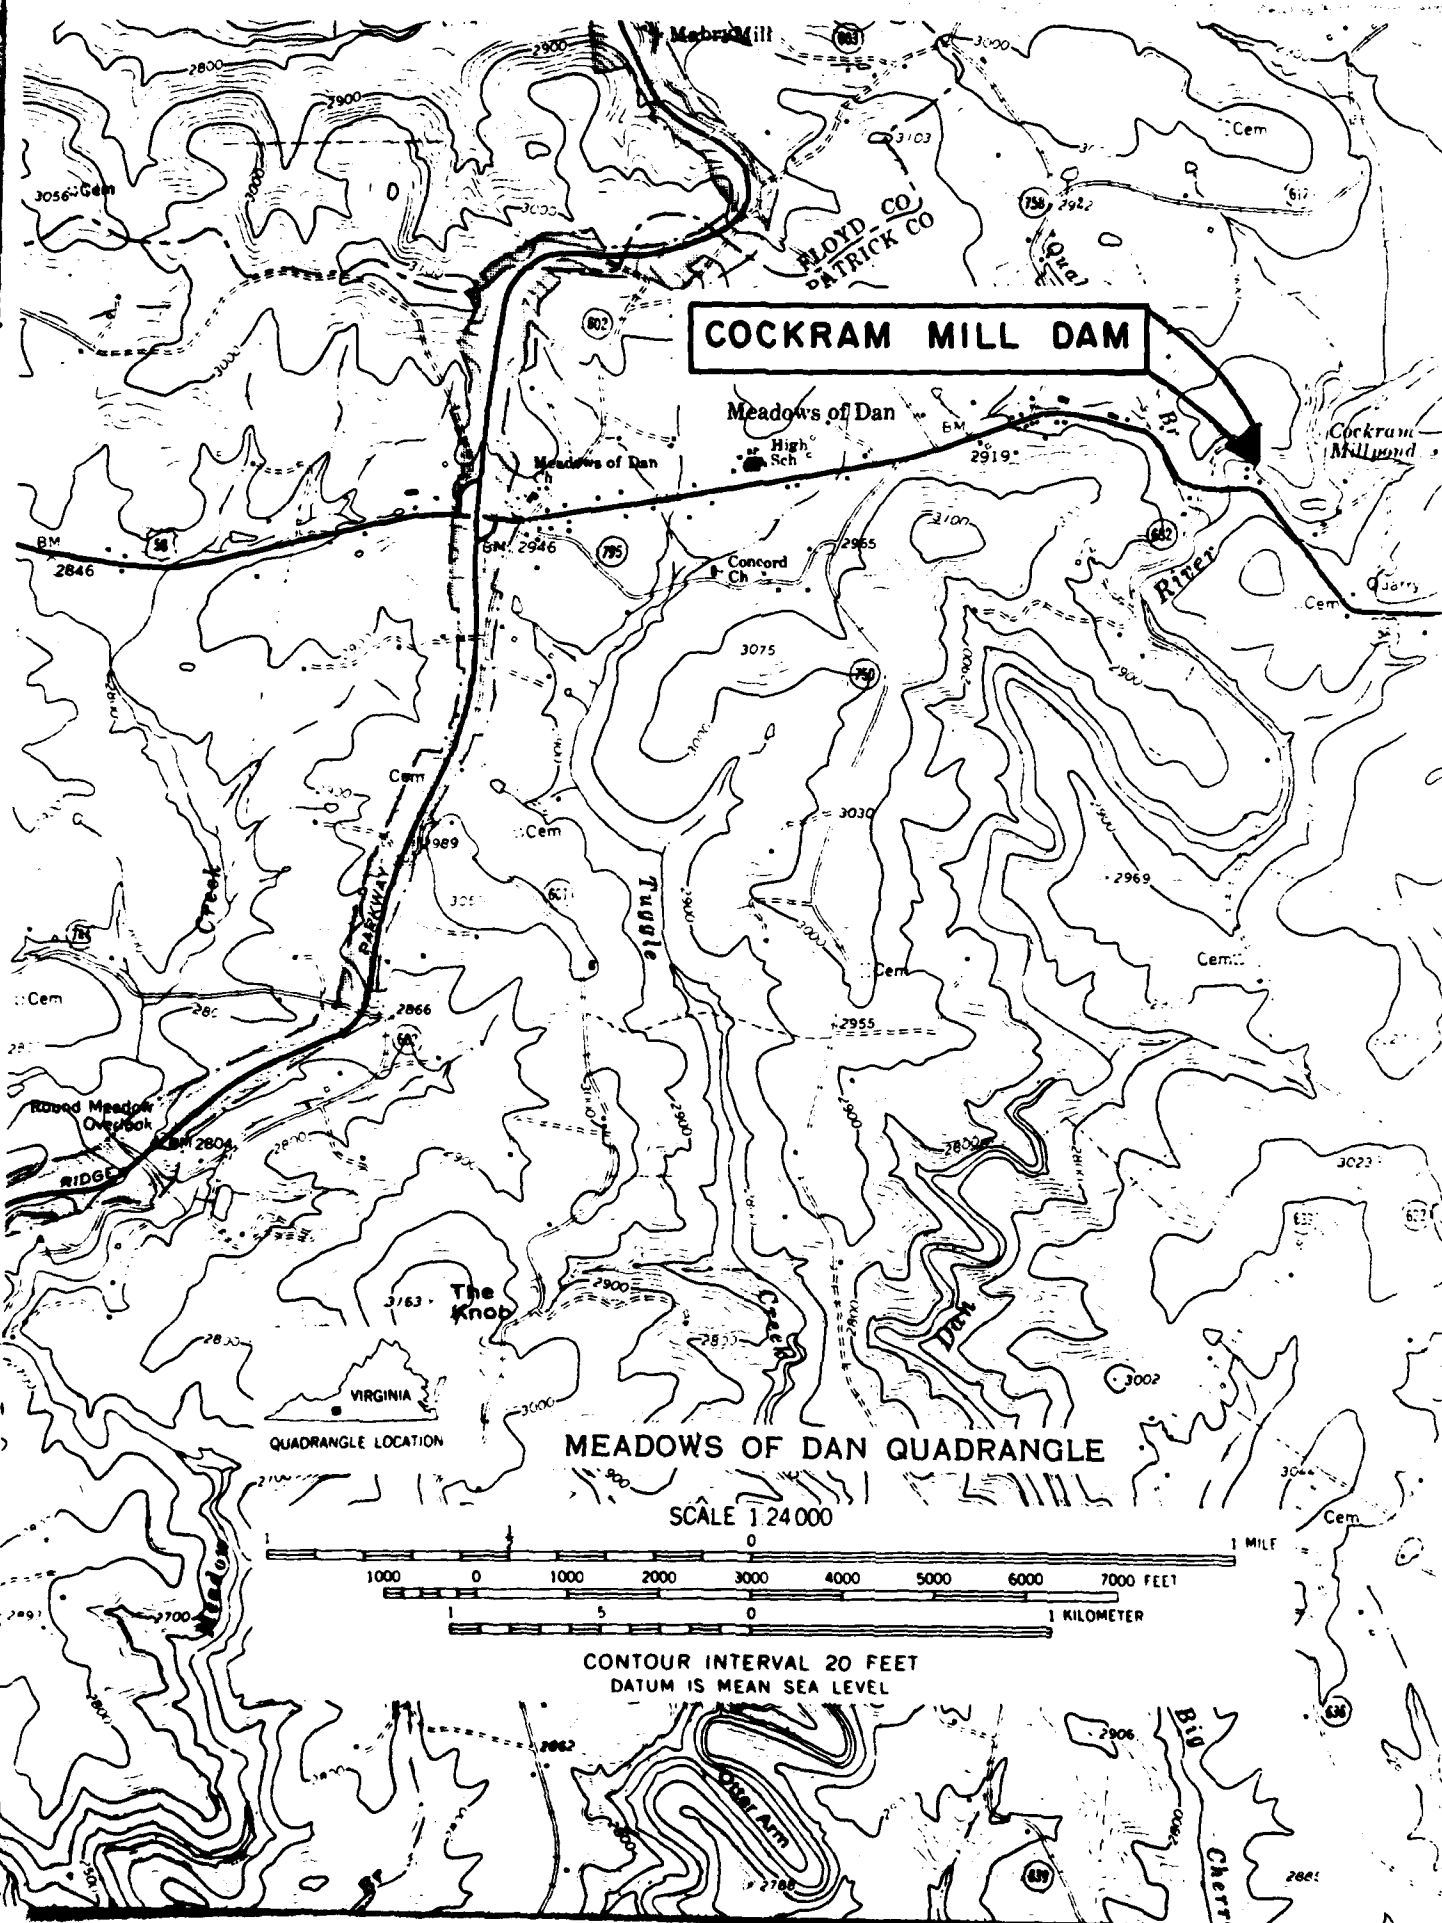
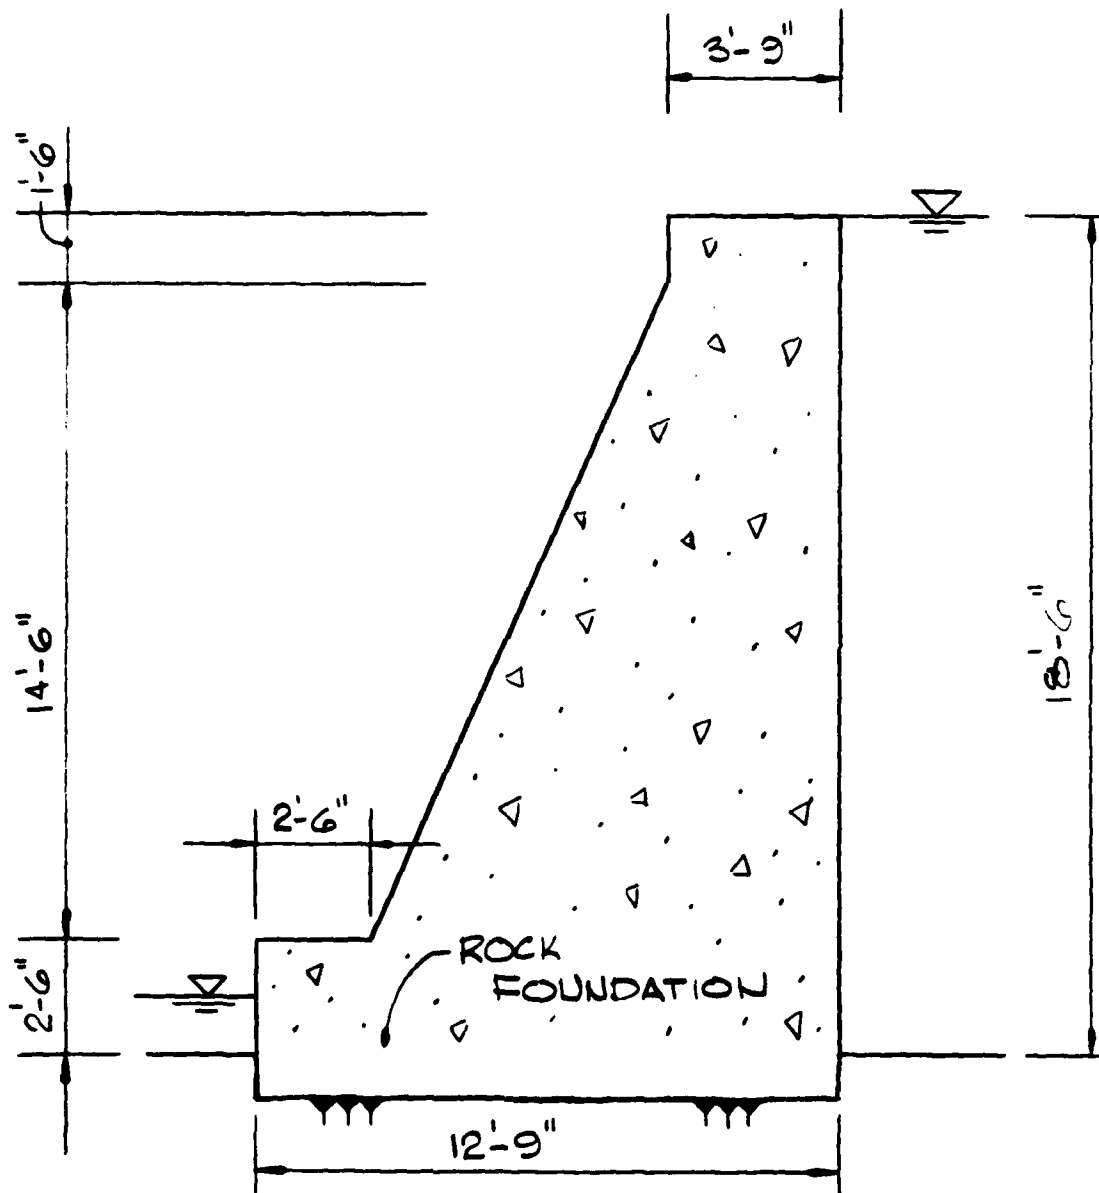
PLATE 1

1.2.1 Dam and Appurtenances: Cockram Dam is a concrete gravity structure about 150 feet long and 19.9 feet high. The base of the dam is 12.75 feet wide. See Plate 1. The dam is founded on rock. The crest of the concrete rectangular 85 foot long spillway is at elevation 2838.56 (ft. m.s.l.). The crest of the spillway is 3.75 feet wide and serves as a walkway. Hand rails are provided across the spillway on the upstream and downstream side of the spillway crest. A four foot wide rectangular notch, located near the center of the spillway, with invert elevation at 2837.06 is blocked by a piece of safety tread type metal plate.

The cross section developed during this field inspection (See Plate 1) is adequate to perform a preliminary evaluation of the overflow section for overturning and sliding. If more detailed analysis is performed in the future, dimensions indicated on Plate 1 should be field verified. This cross section was developed below the wood walkway at the outlet near the right abutment.
